4-Point Inspection Form

Insured/Applicant Name: Miranda Sachs Application / Policy #: 65789

Address Inspected: 46 Beach Road, Bradenton, FL 34205

Actual Year Built: 2015 Date Inspected: 11/21/2025

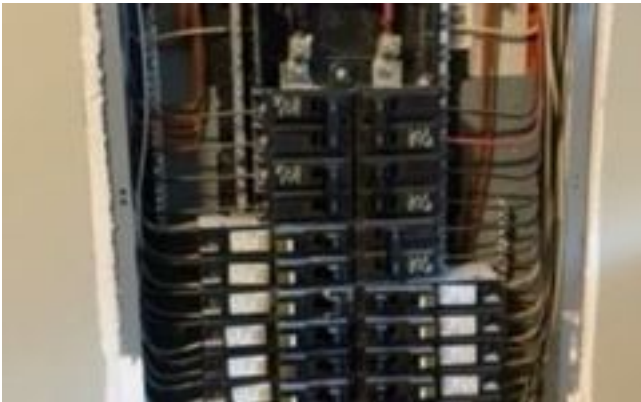
Main electrical service panel with cover removed

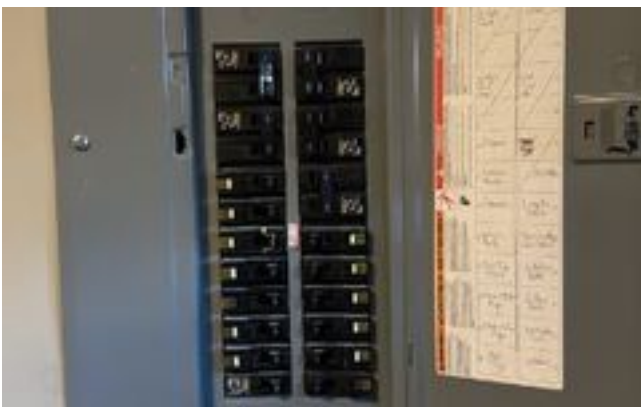
Main electrical service panel open

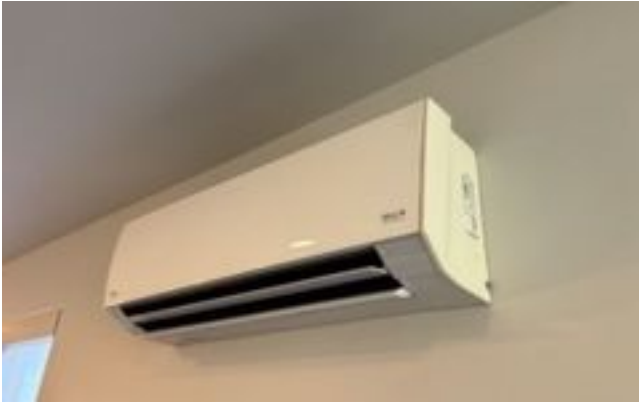
Indoor mini-split head unit

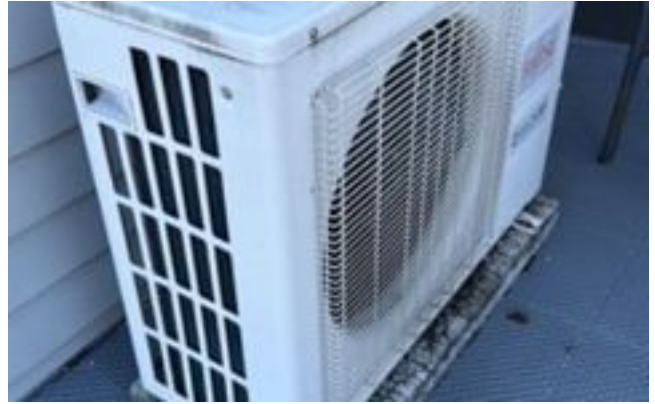
Outdoor Fujitsu condenser mounted on elevated pad

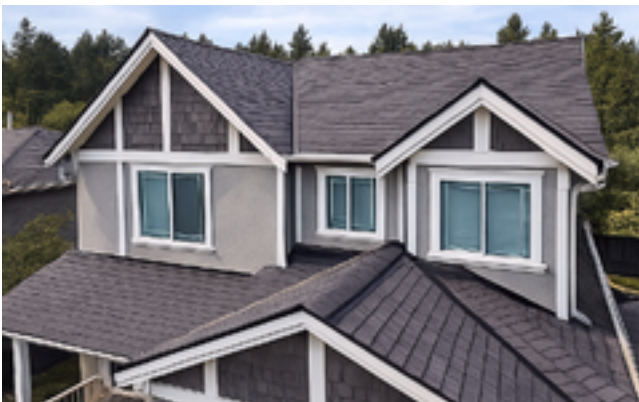
The four major systems of the home were evaluated based on visibly accessible components only. Overall, the dwelling appears to be in serviceable condition with typical age-related wear noted throughout. The roof shows minor granule loss and slight curling on sun-exposed areas but no evidence of active leaks. The electrical system is functional with copper wiring; one double-tapped neutral and an improperly sized breaker were observed and should be corrected by a qualified electrician. The HVAC system operated normally in both heating and cooling modes, though rust staining in the air handler drain pan and a slow-draining condensate line were noted. Plumbing fixtures tested satisfactorily with no active leaks; light corrosion at the water heater connections and a prior dry leak under a sink were observed. These items are common for a home of this age and do not appear to present immediate hazards.

Front-facing roof slopes and gables

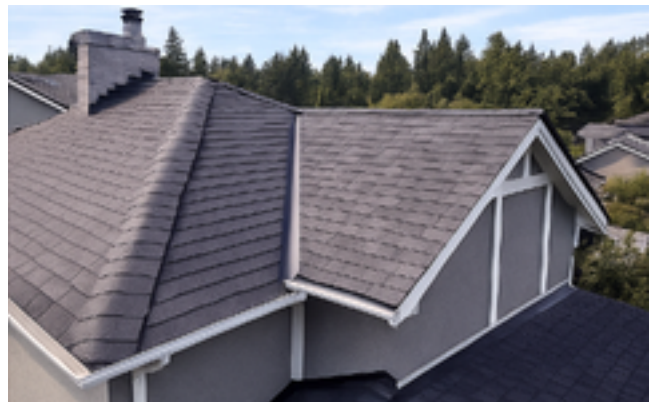
Rear roof slopes, ridge line, and intersecting gables

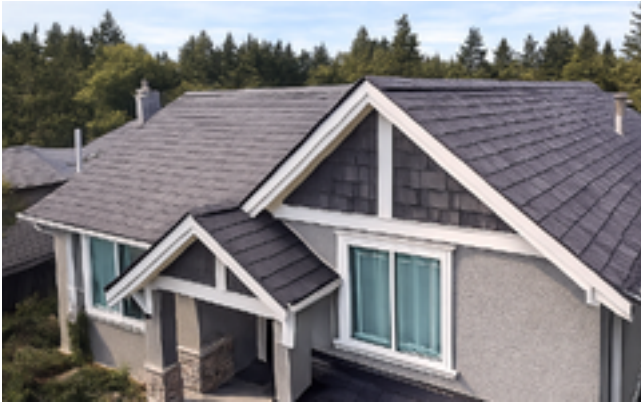
Left front roof slope and entry overhang

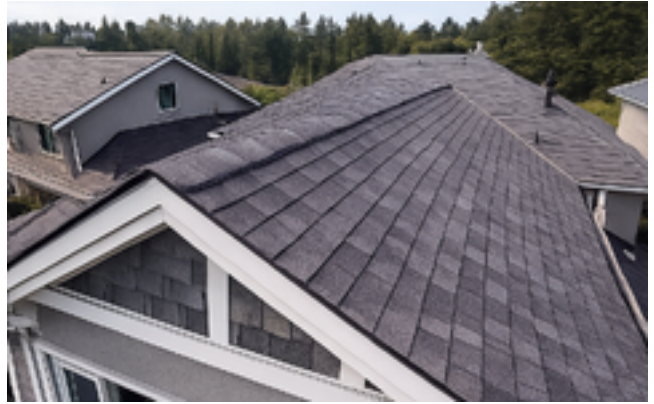
Main upper roof slope and valley intersection

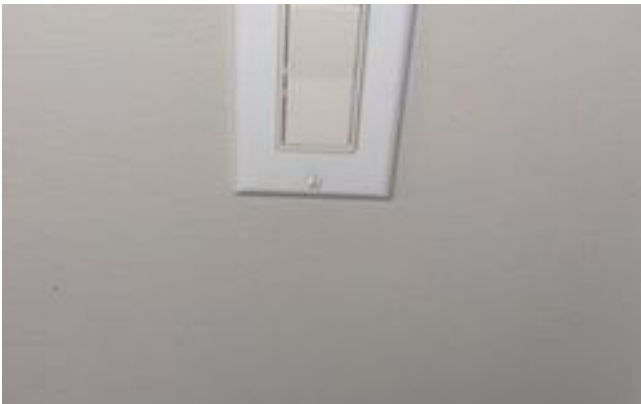
Loose switch plate
